CENTURY MINE MITIGATION STREAM MITIGATION PHOTOGRAPHS
Long Run

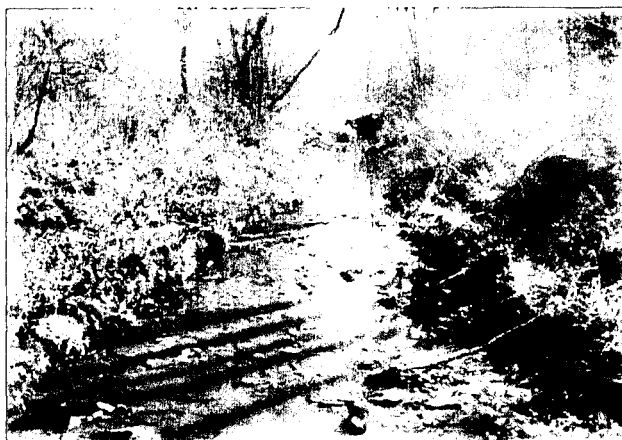
Photograph: 78
LRR-7: Partially successful coir log

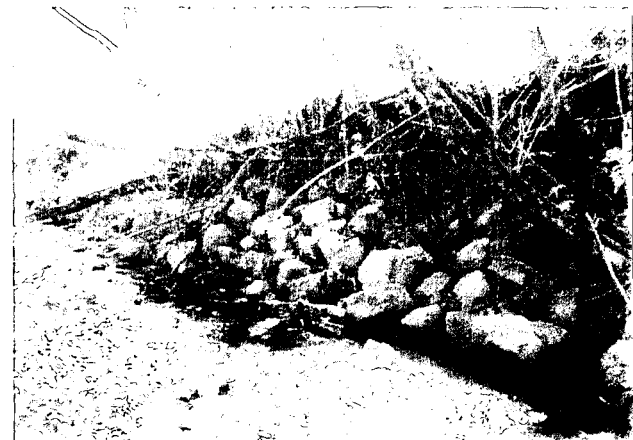
Photograph: 79
LRR-9: Successful boulder and toe protection
